NATIONAL PROGRAM FOR INSPECTION OF NON-FEDERAL DAMS
GEORGIATVILLE POND DAM. (U) CORPS OF ENGINEERS WALTHAM
MA NEW ENGLAND DIV APR 79

GEORGIAVILLE POND DAM

DOCUMENT IDENTIFICATION
APR 1979

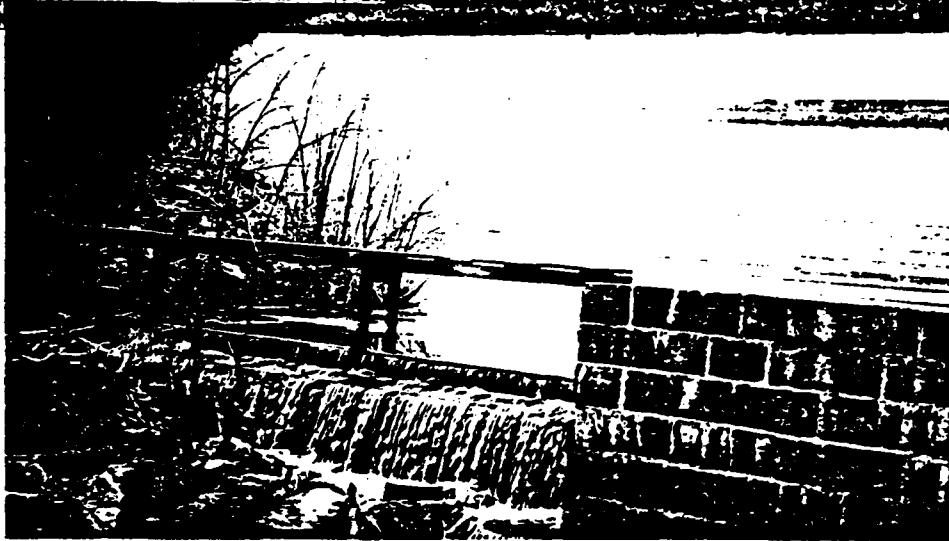
#126 GEORGIAVILLE - LOOKING WEST SHOWS SPILLWAY SOUTH OF GATE-HOUSE WITH 12" FLASH BOARDS IN PLACE TODAY.
12/2/47

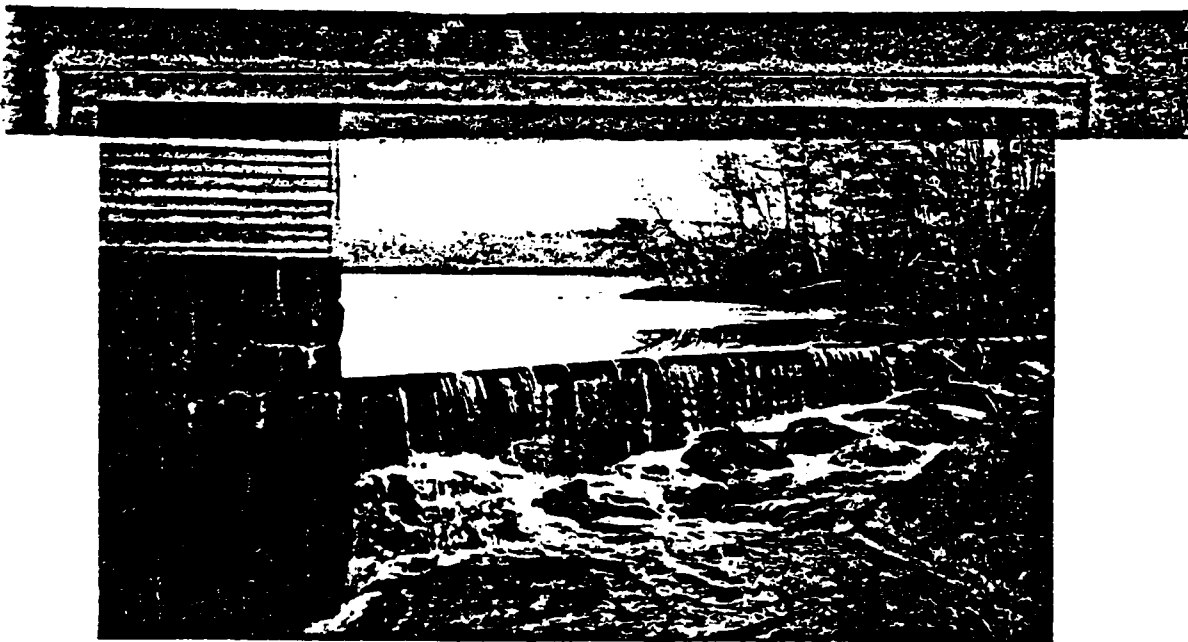
#126 GEORGIAVILLE—LOOKING N W SHOWS SPILLWAY NORTH OF GATE HOUSE. 12/2/47

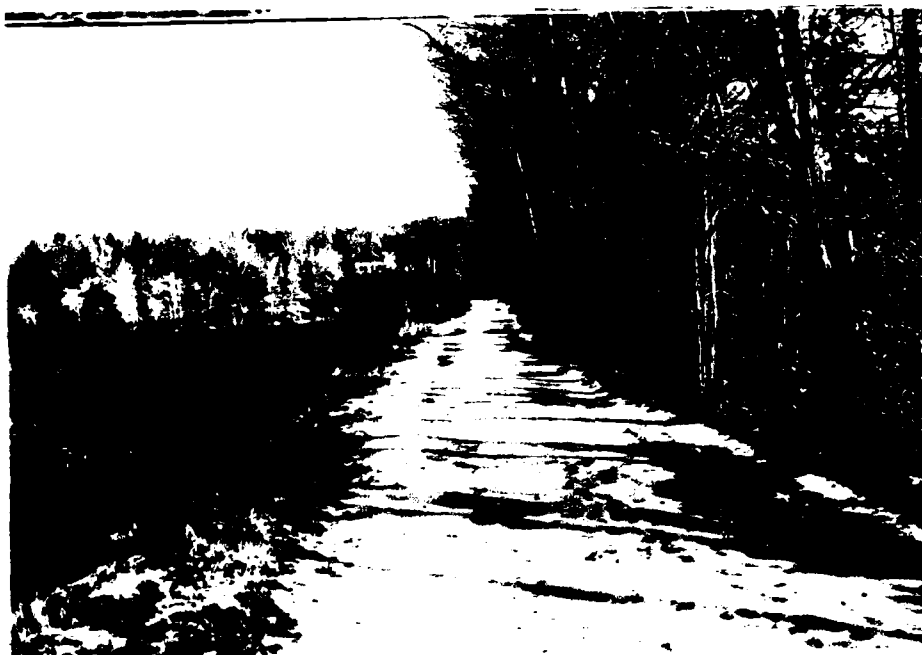
1. Spillway and Training Walls. The outlet gate structure divides the spillway into two sections as shown in photographs C-4 and C-9. The general condition of the structure was judged to be fair to good. The right spillway weir is a concrete cap on a cut stone masonry base. The left weir of the spillway is cut stone blocks. The training walls consist of unmortared stone rubble masonry. The right training wall appears to have many dislodged stones, some of which reduce the effective height of the wall. Stone work is missing from the training wall along the line of the spillway crest, reducing the height of the training wall.

C-4 CREST OF DAM EMBANKMENT

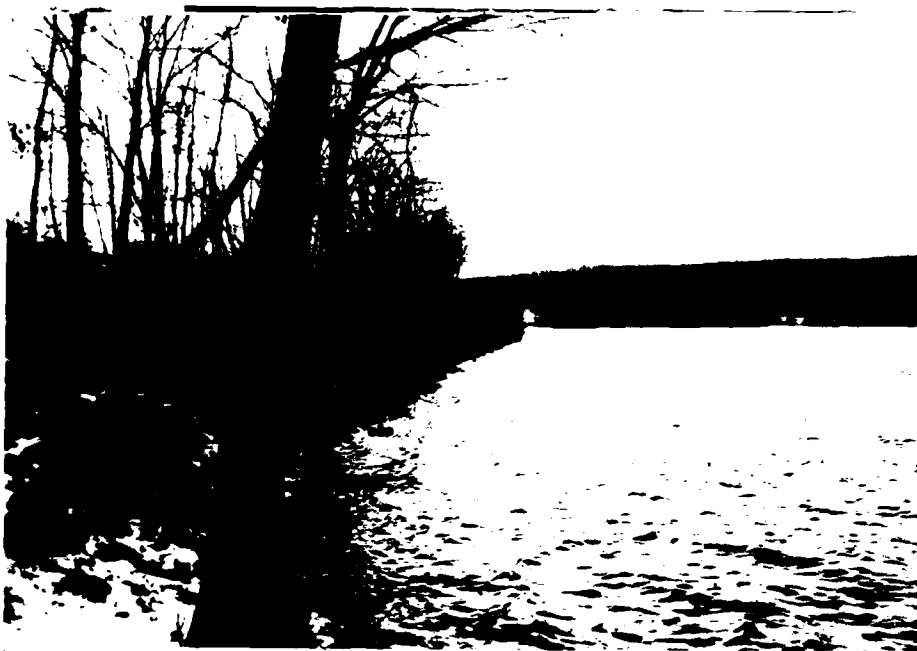
C-2 UPSTREAM FACE OF DAM

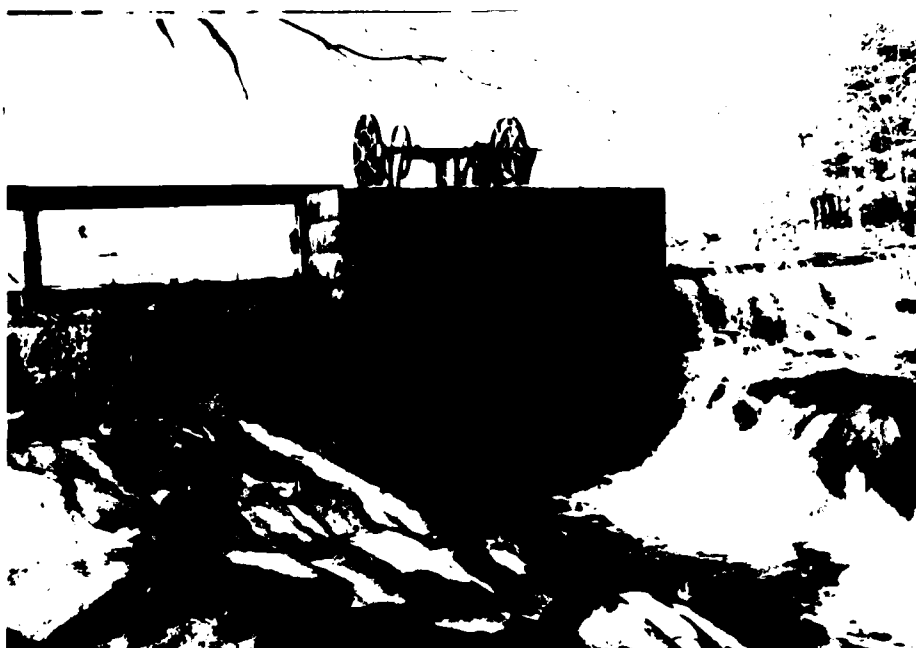
C-9 CONTROL TOWER, LEFT AND RIGHT SPILLWAY WEIRS.

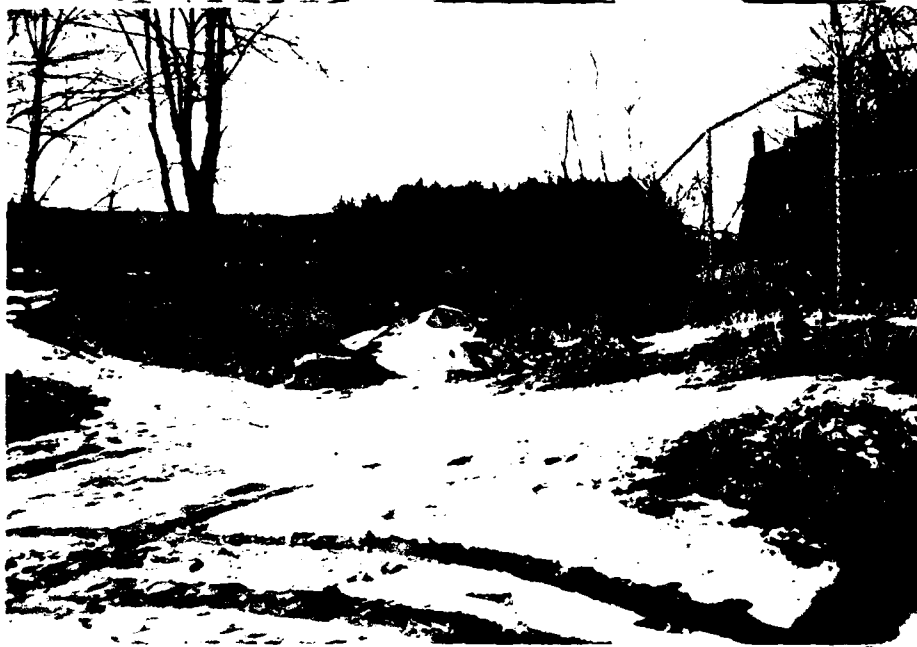
4. Serious reduction in elevation of the crest of the dam along the beach and railroad portion of the embankment.
 5. Reduced cross-section of the embankment caused by old foundations and extensions of abutting property owner's backyards.

C-15 LOW SPOT IN DAM BETWEEN RAILWAY PORTION OF DAM
EMBANKMENT AND MAIN DAM EMBANKMENT

9. A topographic survey of the dam and its appurtenances should be made that will result in accurate drawings of the existing conditions to be used in a program of rehabilitation of the crest of the dam. Those crest areas reduced in elevation to provide beach and parking area as well as cuts in the railroad embankments in the past should be analyzed based on current hydrologic and hydraulic data to establish an acceptable elevation consistent with current criteria.

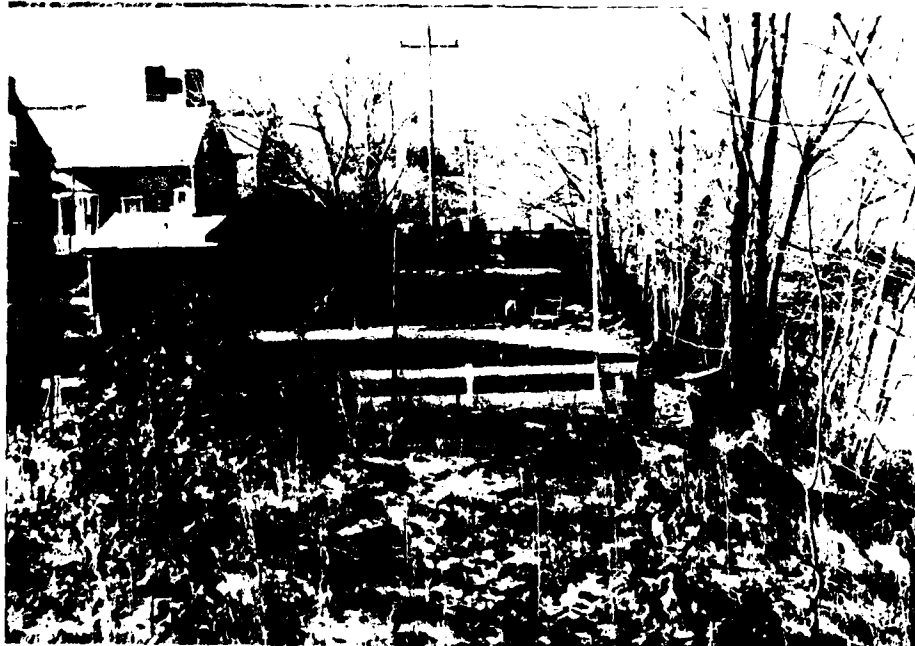
C-16 EXCAVATED PORTION OF RAILWAY EMBANKMENT FORMING
BACKYARD OF LOCAL RESIDENCE.
